# Town of New Marlborough ADA Self Evaluation & Transition Plan

## NEW MARLBOROUGH ADA SELF-EVALUATION & TRANSITION PLAN

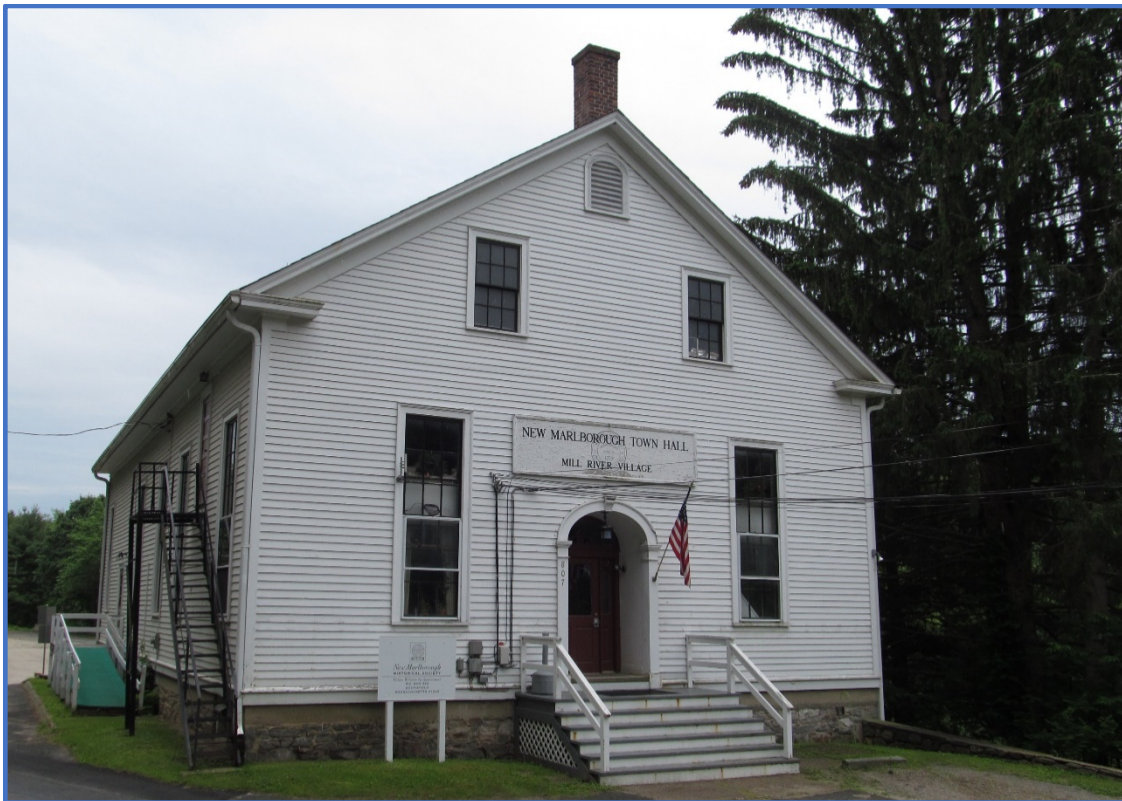
### Evaluation of New Marlborough Town Hall

The Lower level of the Town Hall includes office space for a variety of town services and meeting space for town boards and commissions. However, the Town of New Marlborough has a highly involved public, and often times there is not enough space on the Lower level to hold meetings, requiring that meetings be moved to the Main level.

There is no accessibility to the main level of the New Marlborough Town Hall, where town officials would like to have more of their public meetings. A ramp was built to the main level of the building, but it is completely inaccessible. The ramp is too steep, and the railing is too large to be functional. Inside the building, the only way to get to the bathrooms from the main level is to go outside and around the building to the lower level entrance. Even if the several-inch step into the bathrooms were corrected and lowered, it would still not be accessible from meetings on the main level.

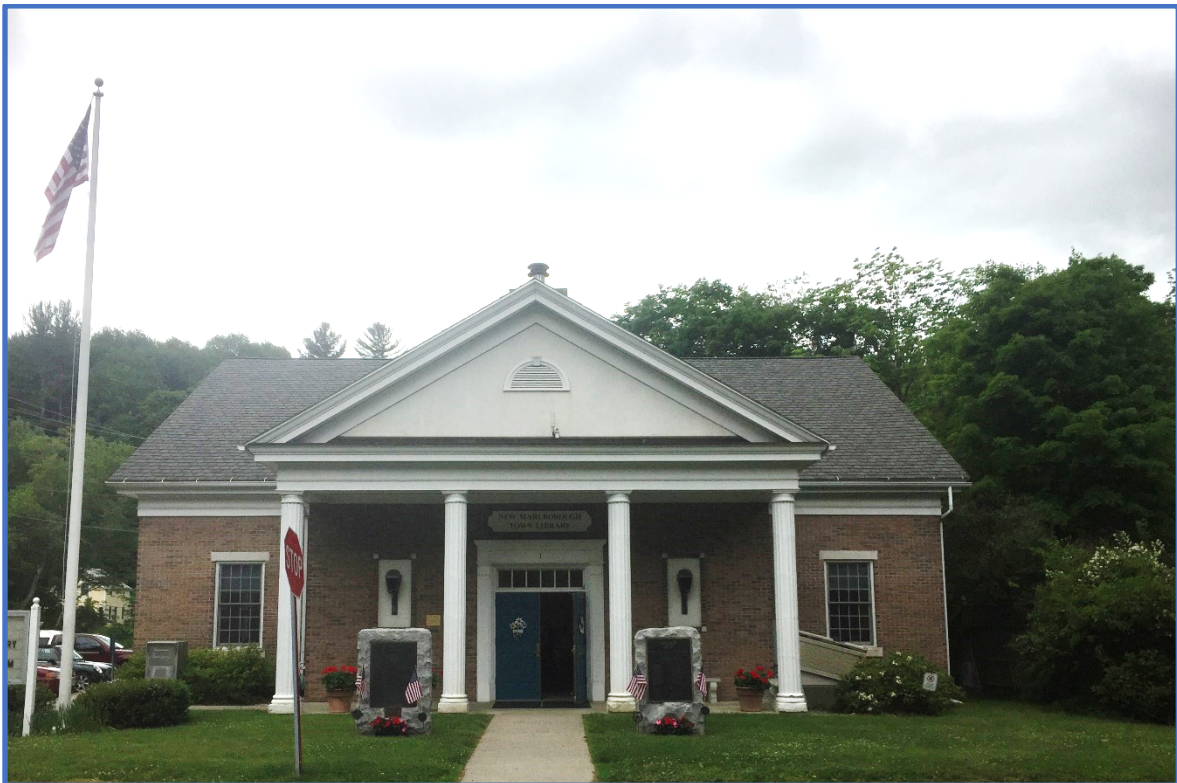
## **Evaluation of New Marlborough Library**

The library is located down the street from the Town Hall and because it is newer, it has much better accessibility to its services. The parking and path to the entrance to library had a few minor barriers including no access aisle at the handicap parking space, an unpaved parking lot, and bumps and cracks on the accessible route. The bathroom door is large and difficult to open. Once in the bathroom, any barriers to accessibility are very minor. Overall, the library and the fire station were the most accessible buildings.

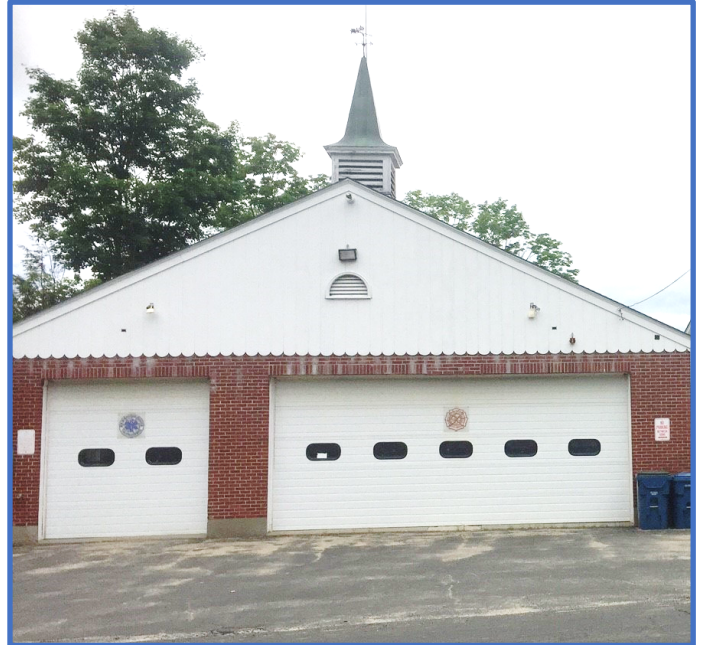
The old fire station in New Marlborough is currently only being used for storage, particularly for town vehicles. The bathrooms have been taken out and the offices are not being used. If the Town is to reuse the building, it will need to be ADA accessible. On the exterior of the building, the parking lot is shared with the new fire station. The parking lot does not have delineated parking spaces, so there is not handicap space nor is there any access aisle or signage. The entrance to the building is inaccessible to anyone in a wheelchair because the accessible route is too narrow, and it is dilapidated.

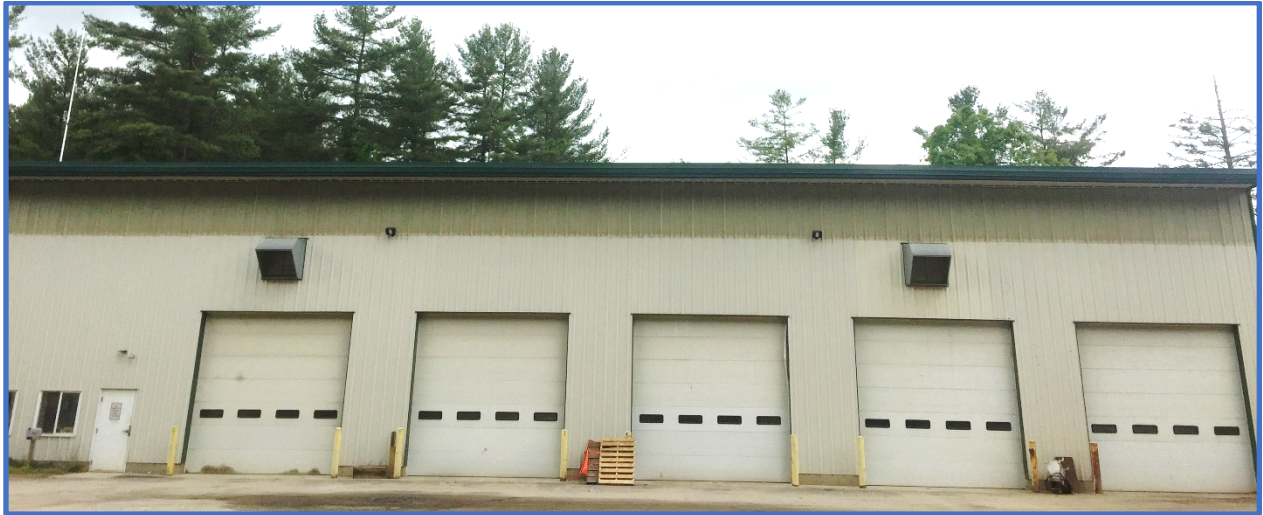
## **Evaluation of New Marlborough Highway Garage**

The Highway Garage was an interesting building that probably has more accessibility than many other highway garages, because the highway superintendent is also the fire chief and spends a limited number of hours at the Fire Station.

There is no designated parking at the highway garage, and the parking lot is unpaved and is a possible tripping hazard. When in the highway garage, there is an office to the left and a bathroom down the hall. While the restroom complies with AAB regulations, the accessible route passes by large trucks with mirrors that jut out into the accessible route, as well as automobile parts propped up against the wall of the accessible route. In the bathroom, the placement of the trashcan made the available maneuverability for someone in a wheelchair less than is required by ADA. All these concerns do not cost anything to remedy but does require awareness by employees that these small barriers can inhibit free travel by people who have a disability.

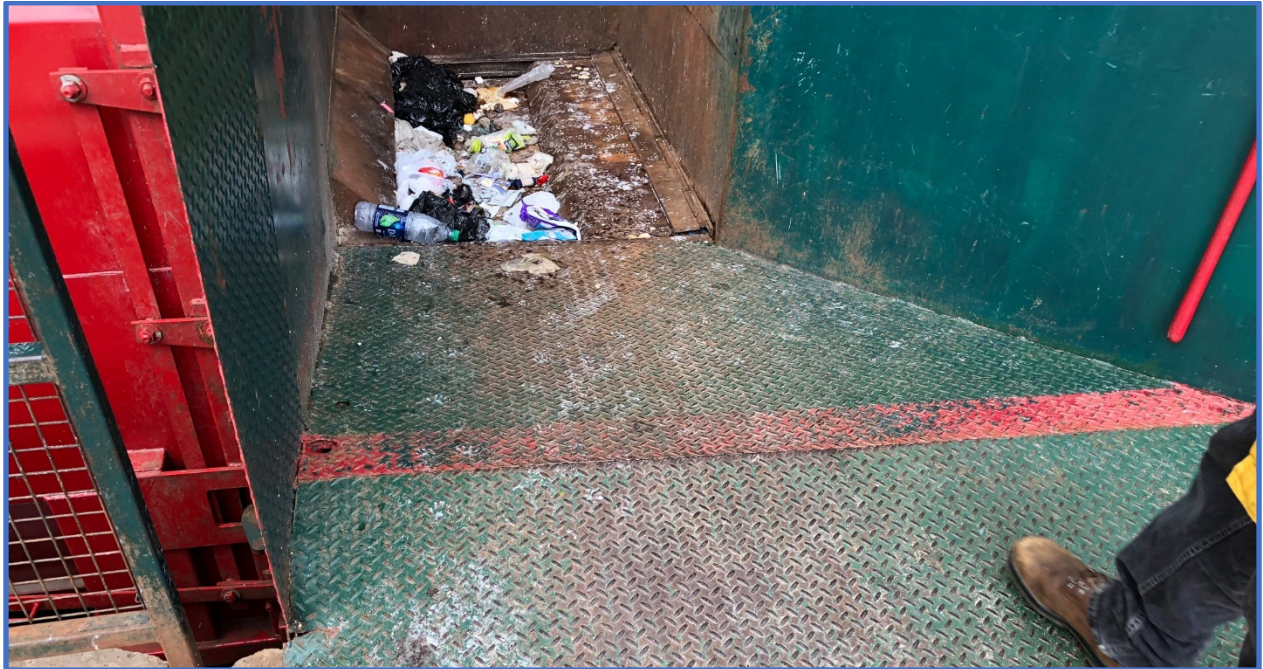
## Evaluation of the Town Transfer Station

The town transfer station is where residents drop off their trash and recycling. It is located at South Sandisfield Road. It includes two large trash compactors, one recycling drop-off, and a swap shop where residents can swap items at a small building on the transfer station lot.

The transfer station was also evaluated for accessibility. As a method for disposing of waste, it seems to be effective, and parking is not a concern because it is permitted to pull up close to the trash compactors. However, there is also a swap shop which allows people to trade items that people leave in the shop. The swap shop is an enclosed building, and therefore requires some compliance with accessibility. First, the parking is beyond the route that cars travel by to access the trash compactors. This could be dangerous to traverse from the accessible parking. There is also no designated parking for people with disabilities. The accessible route is unpaved and dangerous to traverse. If someone who is blind or in a wheelchair can get to the swap shop, there is a large step in order to get into the building. When in the building, there is little maneuverability.

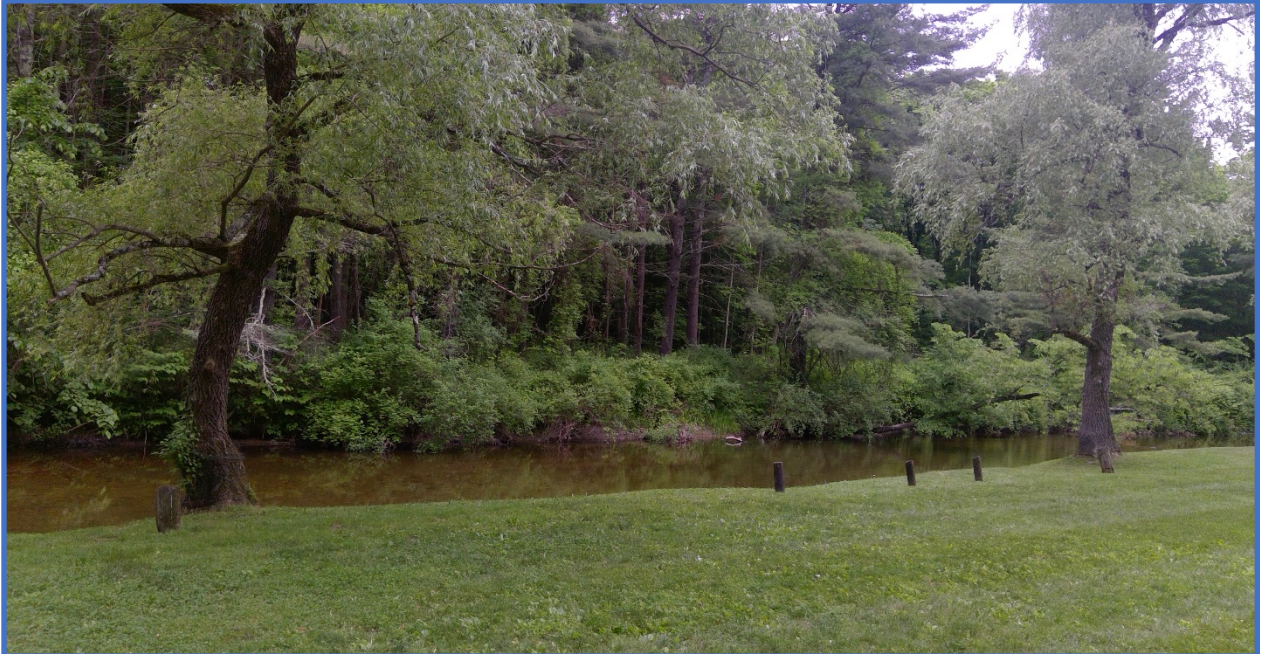
## Evaluation of Umpachene Falls Park

Umpachene Falls Park is the only town-controlled recreational site in New Marlborough. Like most other town-controlled sites, there are not any designated handicap parking spaces. A non-accessible porta potty is in the parking lot and far away from the entrance to the actual park. Once in the park, there is very little accessibility for people with disabilities including non-accessible picnic tables, play equipment, and general pathways.
